The Old Rectory TPO
Little Gransden

Report by Structural Engineer

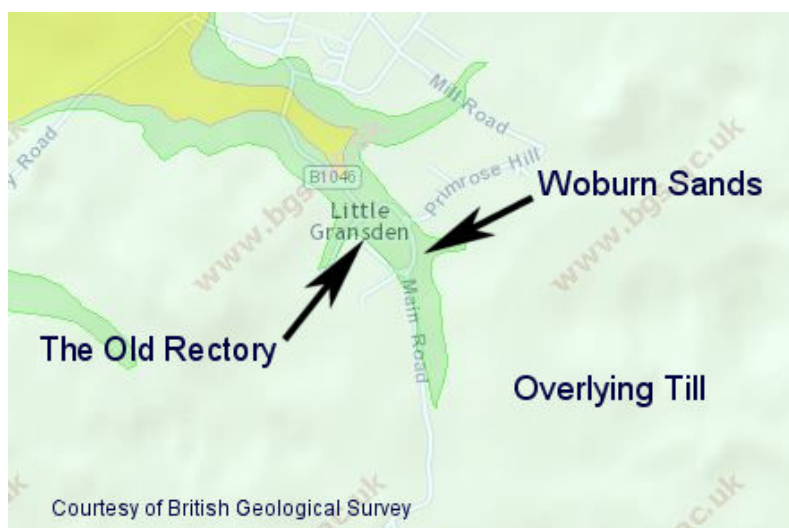
Figure 1. Extract from Geological Map

- 5.4 The clay described in Mat Lab's site investigation report appears to be the feather edge of a superficial deposit referred to as Till on the Geological Survey map, an extract of which is shown below, in figure 1. This is as described in the letter dated 5 March 2012, from Dr Charles Turner and is referred to by Dr Biddle (para 12). Till was called Boulder Clay on earlier versions of the geological map. It is essentially a variable, sandy or silty clay deposit and laboratory tests carried out by Mat Lab have shown it to have intermediate shrinkage potential.
