ADDENDUM TECHNICAL REPORT

Crawford Reference: SU1000736

**Mr A Seabright
The Old Rectory
Little Gransden
Sandy
Bedfordshire
SG19 3DU**

SUBSIDENCE CLAIM

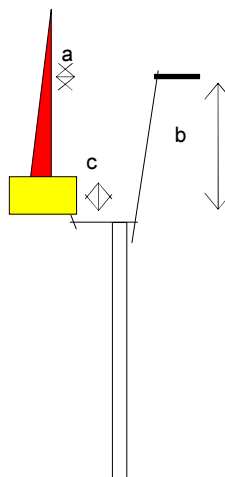
Foundation Details

A trial hole was excavated to expose the foundations - see site plan for location and the diagram below for details. The trial pit revealed that the walls of the house at the left flank are built off a 170mm thick concrete strip foundation bearing at a depth of 270mm below ground level in soft to firm brown slightly sandy clay. Roots up to 2mm in diameter were observed at the underside of the foundation.

No.	Borehole Depth	Footing (a)	Underside (b)	Thickness (c)
TH1	3.50 m.	0 mm.	270 mm.	170 mm.
