DESKTOP STUDY ON INVOLVEMENT OF TREES

AS CAUSE OF SUBSIDENCE DAMAGE TO

THE OLD RECTORY,

LITTLE GRANSDEN, CAMBS, SG19 3DU

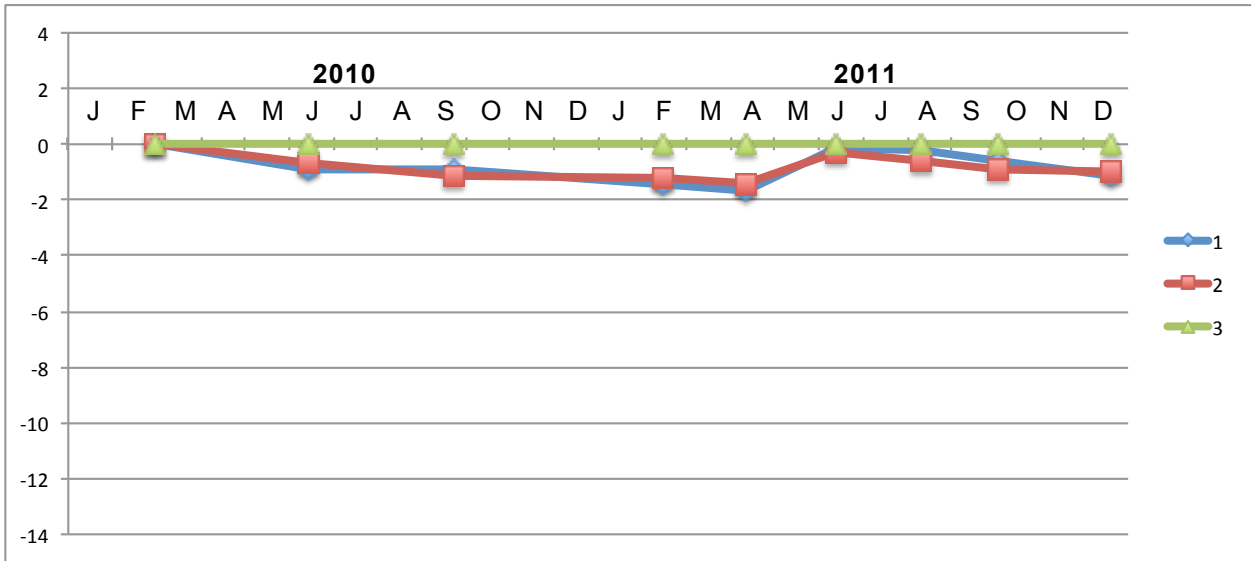
Stations 1 - 3.

- ii. Stations 9 – 11 show possible very slight seasonal subsidence in 2011, but there is no clear pattern in 2010.
 - iii. Movements at stations 1 – 3 are very small and not indicative of any pattern.

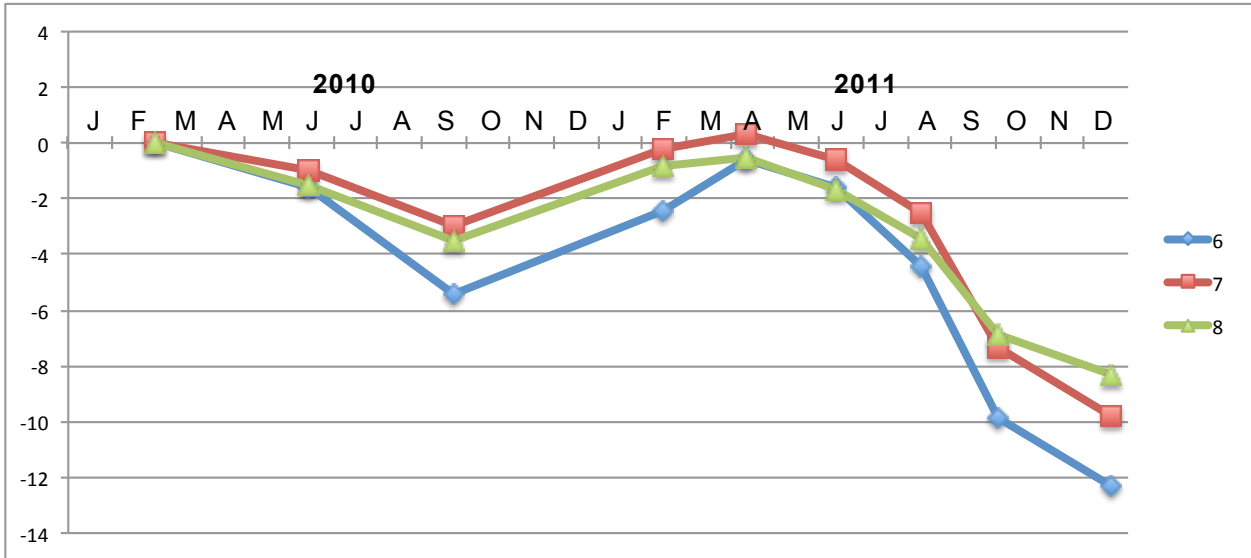
Stations 6 - 8.

9. I draw attention to the following features:
 - i. There is a clear pattern of seasonal movement at station 6, 7 and 8, diagnostic of the involvement of root activity of vegetation. The greatest movement, with a seasonal amplitude of 12.3mm, is at station 6.

10. The 12mm movement at station 6 would be sufficient to cause damage. Although I have not seen any detailed description of the damage, I understand that it is in this area.

21. The level monitoring clearly demonstrates that root activity of vegetation is causing seasonal movements of the foundations in the vicinity of stations 6, 7 and 8.

31. If it is definitely established that the cedar is the cause, I agree that felling would prevent any further seasonal movement. There is no risk of long-term heave. If the tree is felled any time before seasonal drying recommences in May, the foundations would immediately be stable.

32. However, in this situation it would appear that underpinning to correct the variations in foundation depth would be a more appropriate remedy. Increasing the depth of the foundations in the area of movement so they bear on the underlying sand at 1.5m should prevent any further seasonal movement. The level monitoring shows that the movements are restricted to the area of stations 6, 7, and 8. Localised partial underpinning of the shallow foundations in that area would correct their inherent inadequacy, and should prevent any further root-induced damage.
