15th May 2012

Re: The Old Rectory, 1 Church Street,
Little Gransden, Sandy, SG19 3DU

A) *The involvement or otherwise of the tree in subsidence damage at the above*

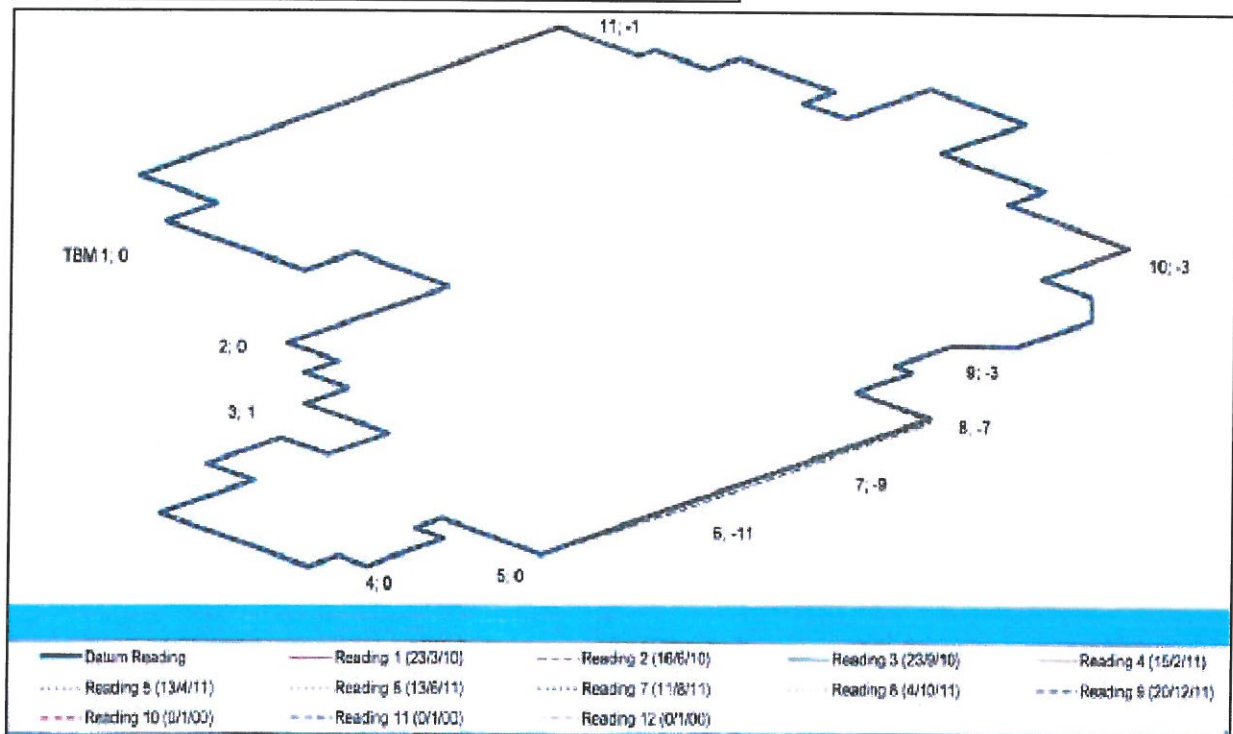
Level monitoring (station numbers left, summary below -

graph below) confirms a seasonal pattern of damage with levels rising in winter and falling in summer : it can safely be concluded that vegetation is involved in the damage.

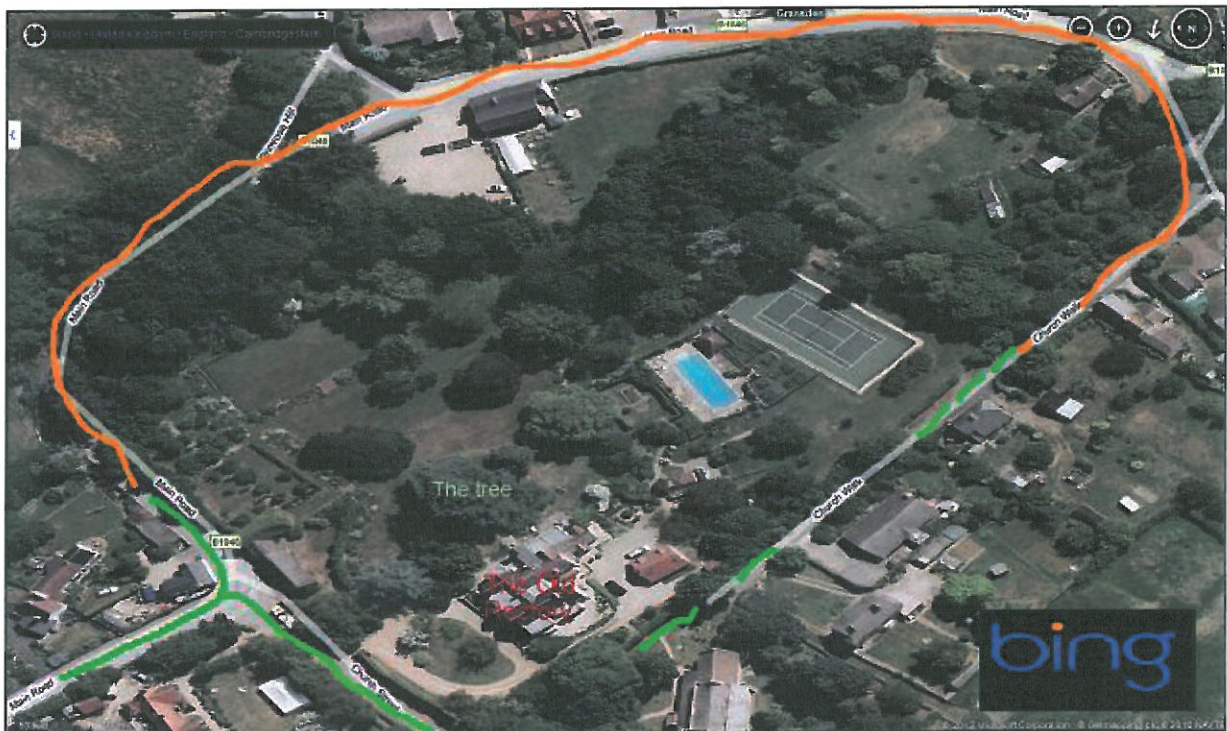
The tree in question is a cedar of Lebanon (*Cedrus libani*) 22m in height and 1590mm in trunk diameter at 1.5m above ground level. It is, thus, large and is clearly partly visible from public places. In support of this I noted that the tree is prominently visible from Church Street, and from the B1046 to the N of the site, from which it dominates the view on approach to the village.

The **green** line superimposed on the aerial view above indicates positions on public roads from which the tree is clearly visible. The **orange** line indicates positions on public roads from which the tree is largely invisible, although there are, from certain positions in this zone, glimpse views of the tree through a screen of other trees or vegetation.

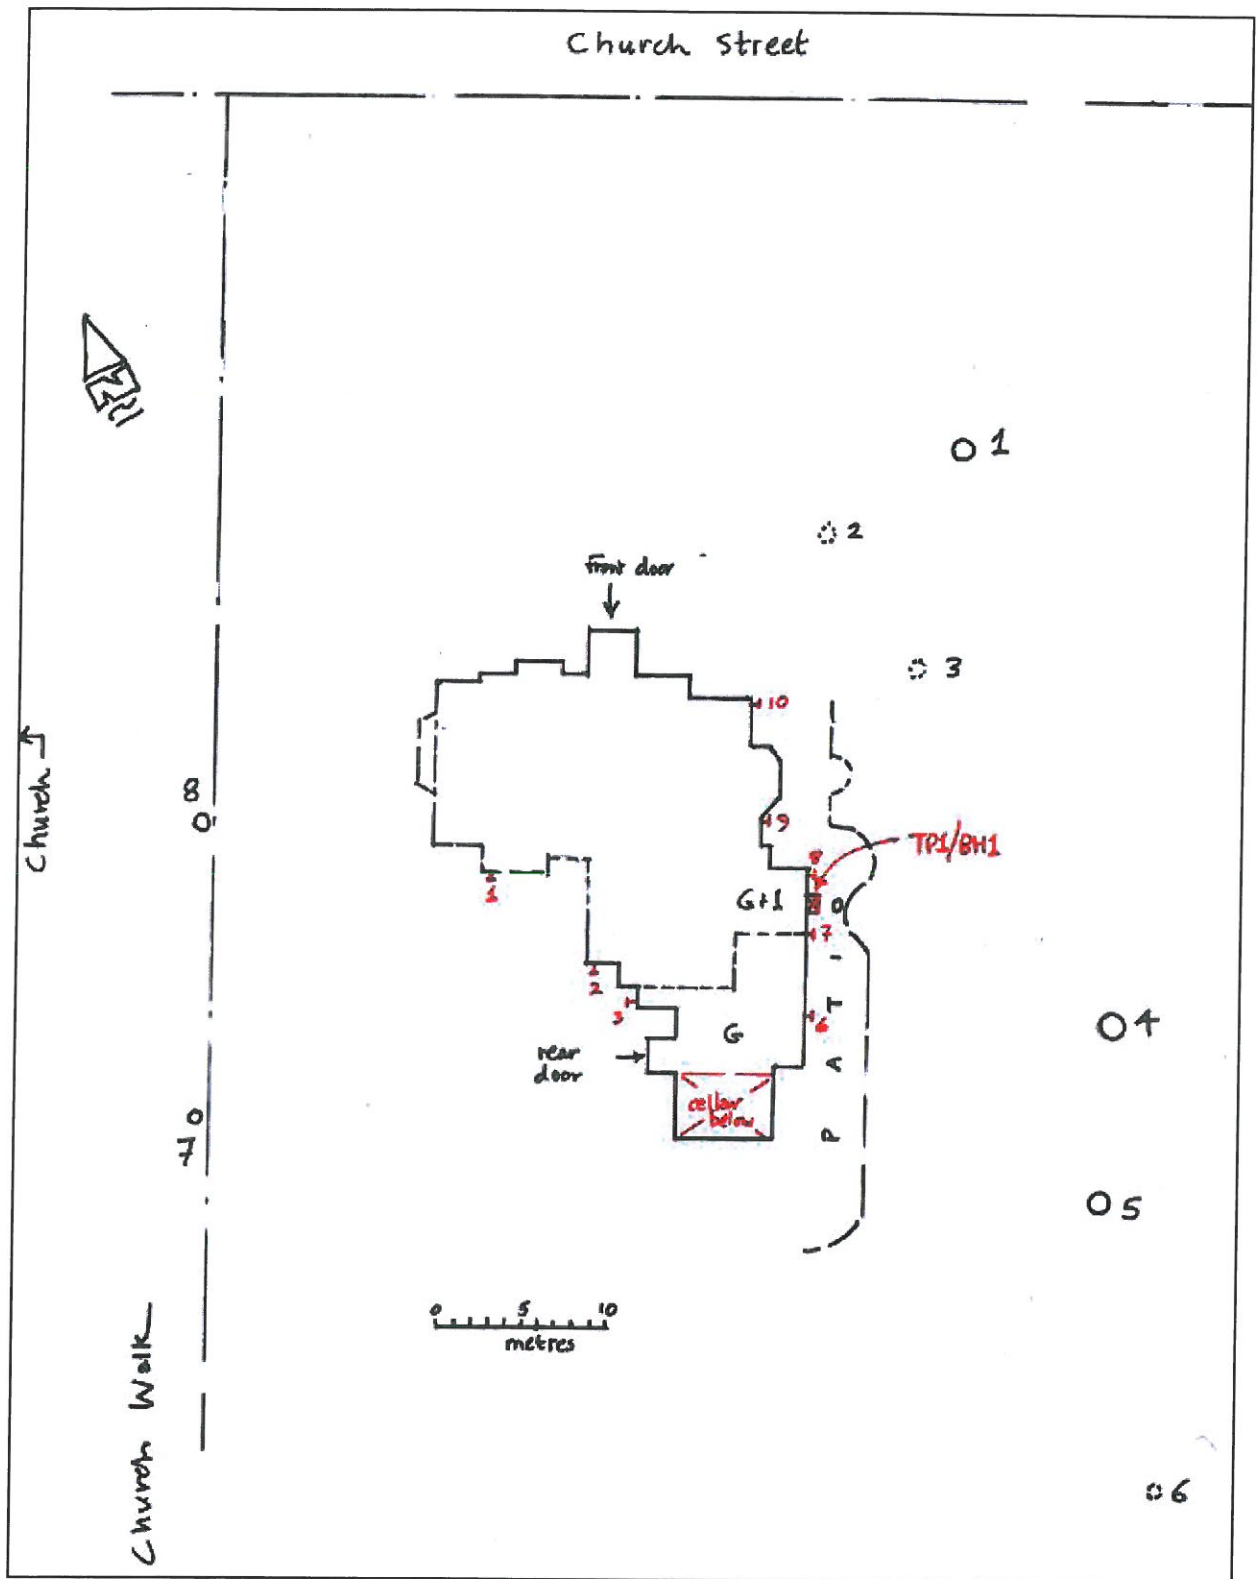
PLAN and PHOTOGRAPH

Sketch plan, drawn to 1:400@A4. Please read in conjunction with tree data table above. N.B. I have marked only the level monitoring stations I saw on site.
