## Consultant Report Advice Note

# Arboricultural Implication Assessment

## Consultant Report on Trees

<b>For:</b>	<b>Client:</b>	Crawford & Company
	<b>Insurer:</b>	Chubb Insurance Company of Europe S.A
<b>Site:</b>	<b>Policyholder:</b>	Mr A Seabright
	<b>Risk Address:</b>	The Old Rectory, Little Gransden, Sandy, Bedfordshire, SG19 3DU.
<b>Refs:</b>	<b>OCA Ref:</b>	44251
	<b>Client Ref:</b>	SU1000736

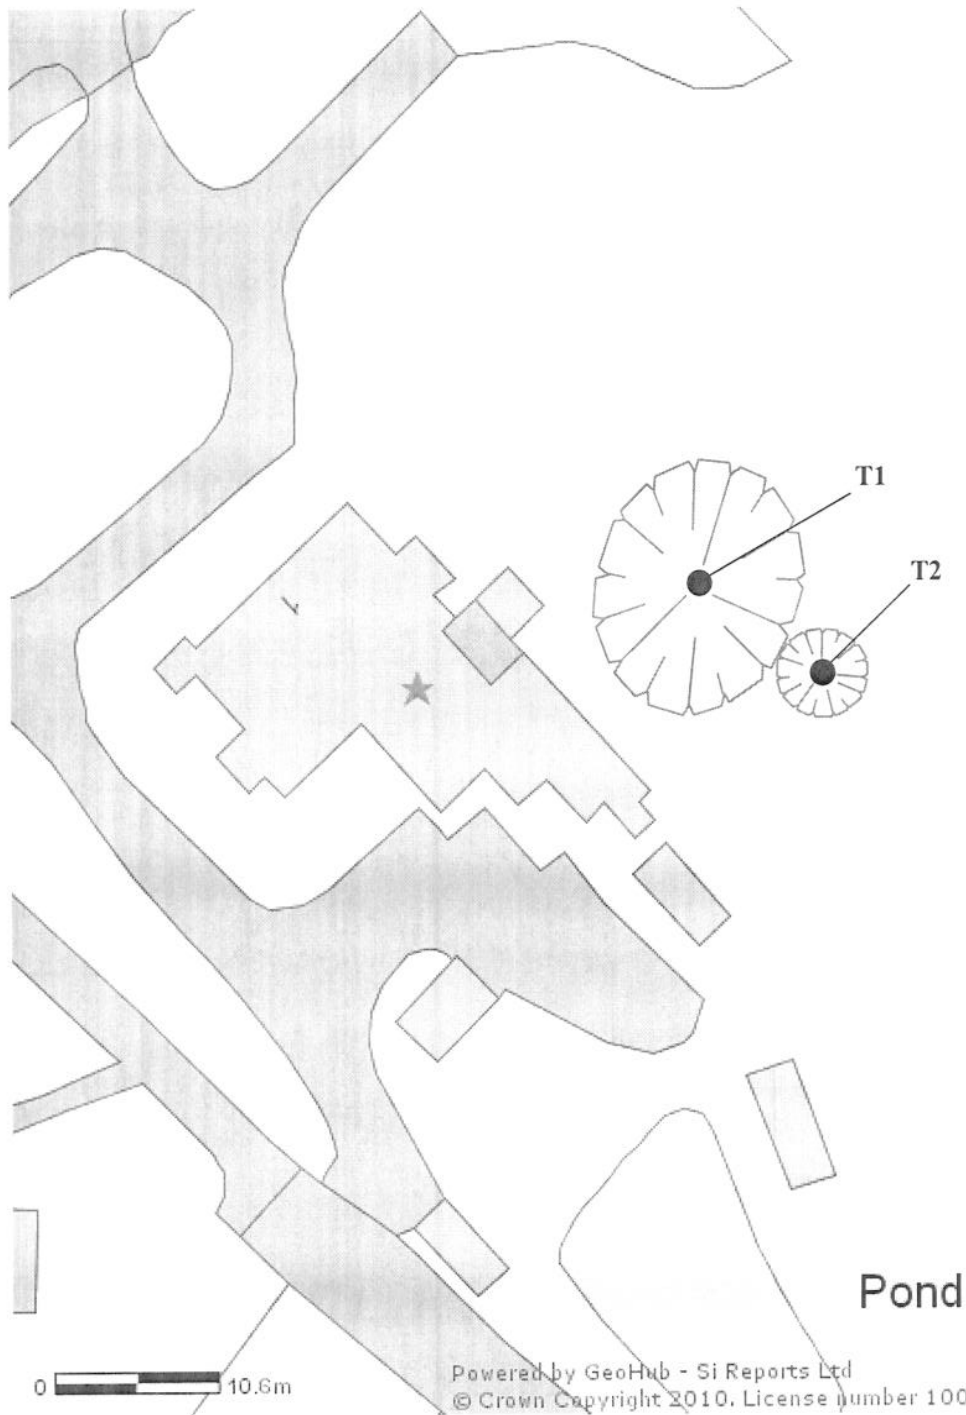
Within the garden of the Insured Property is an individual Cedar tree which is visually prominent and located approximately 19m from the rear elevation of the property: it is the closest source of the Cedar roots found underside of foundations.

Details of the above mentioned vegetation is included in the vegetation survey table at s.11.0 of this report and its location is shown on the site plan at the end of this report.

The Cedar tree (T1) is one of two very significant trees growing proximate the area of damage (the other being Wellingtonia T2). The Cedar will be acting as a significant influence on soil moisture levels beneath the foundations of the property. Therefore we consider that this tree is the material cause of the current damage.

Tree No:	Species	Works Required	Ownership
T1	Cedar	Considered retention in conjunction with a root barrier	Policyholder
