ADDENDUM TECHNICAL REPORT

Crawford Reference: SU1000736

**Mr A Seabright
The Old Rectory
Little Gransden
Sandy
Bedfordshire
SG19 3DU**

SUBSIDENCE CLAIM

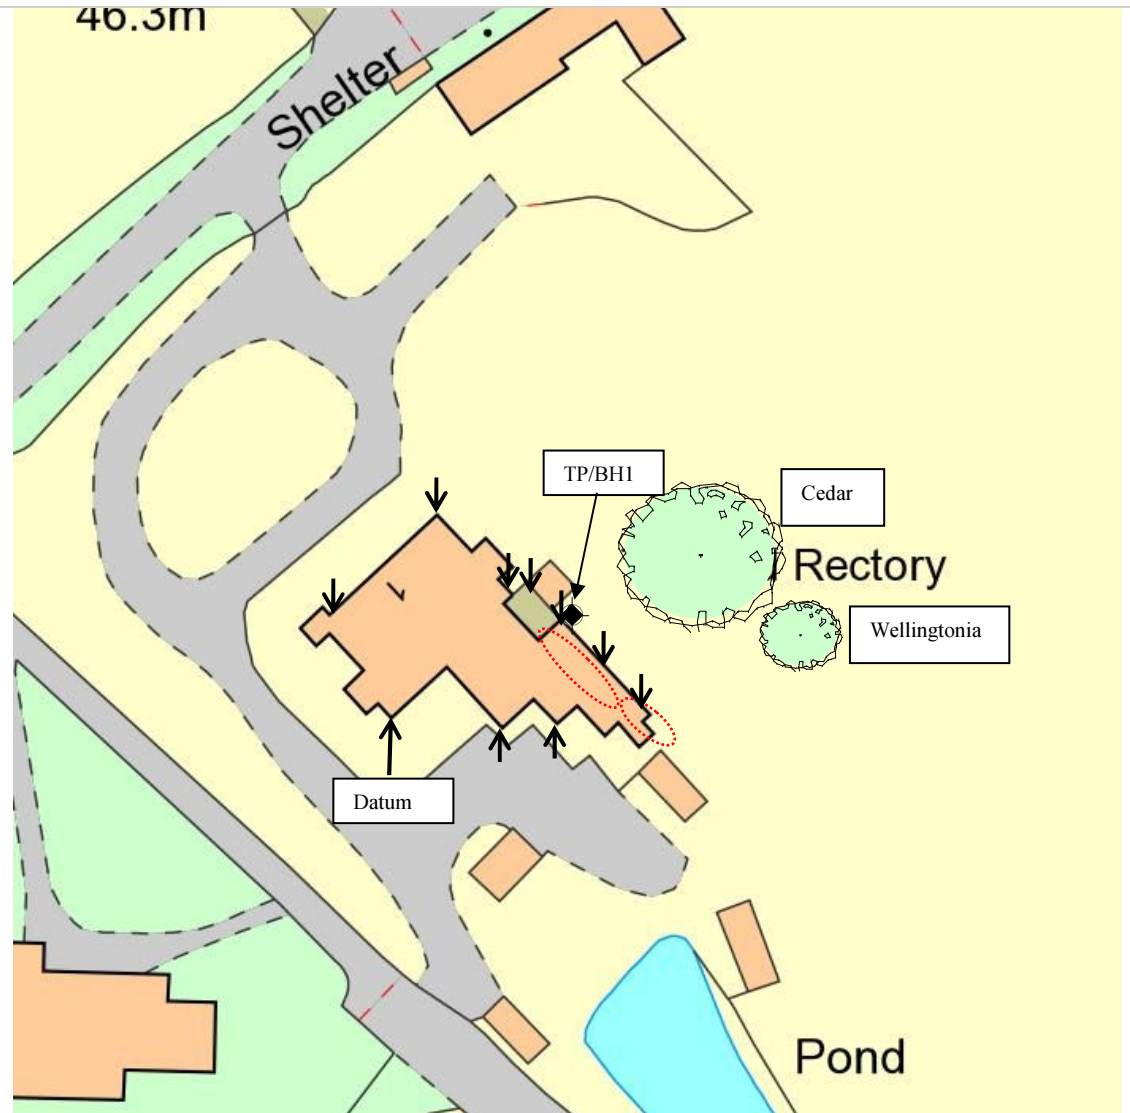
Site Plan

Area of Damage

The results of our investigation lead us to conclude that the cause of recent movement in the building has been shrinkage of the clay component in the upper layer of soil promoted by the moisture demands of the large Cedar tree growing near-by.

If further movement in the building is to be prevented, effective management of the Cedar tree is required so as to negate its impact on the moisture content of the soil below the foundations.
