15th May 2012

Re: The Old Rectory, 1 Church Street,
Little Gransden, Sandy, SG19 3DU

A) *The involvement or otherwise of the tree in subsidence damage at the above*

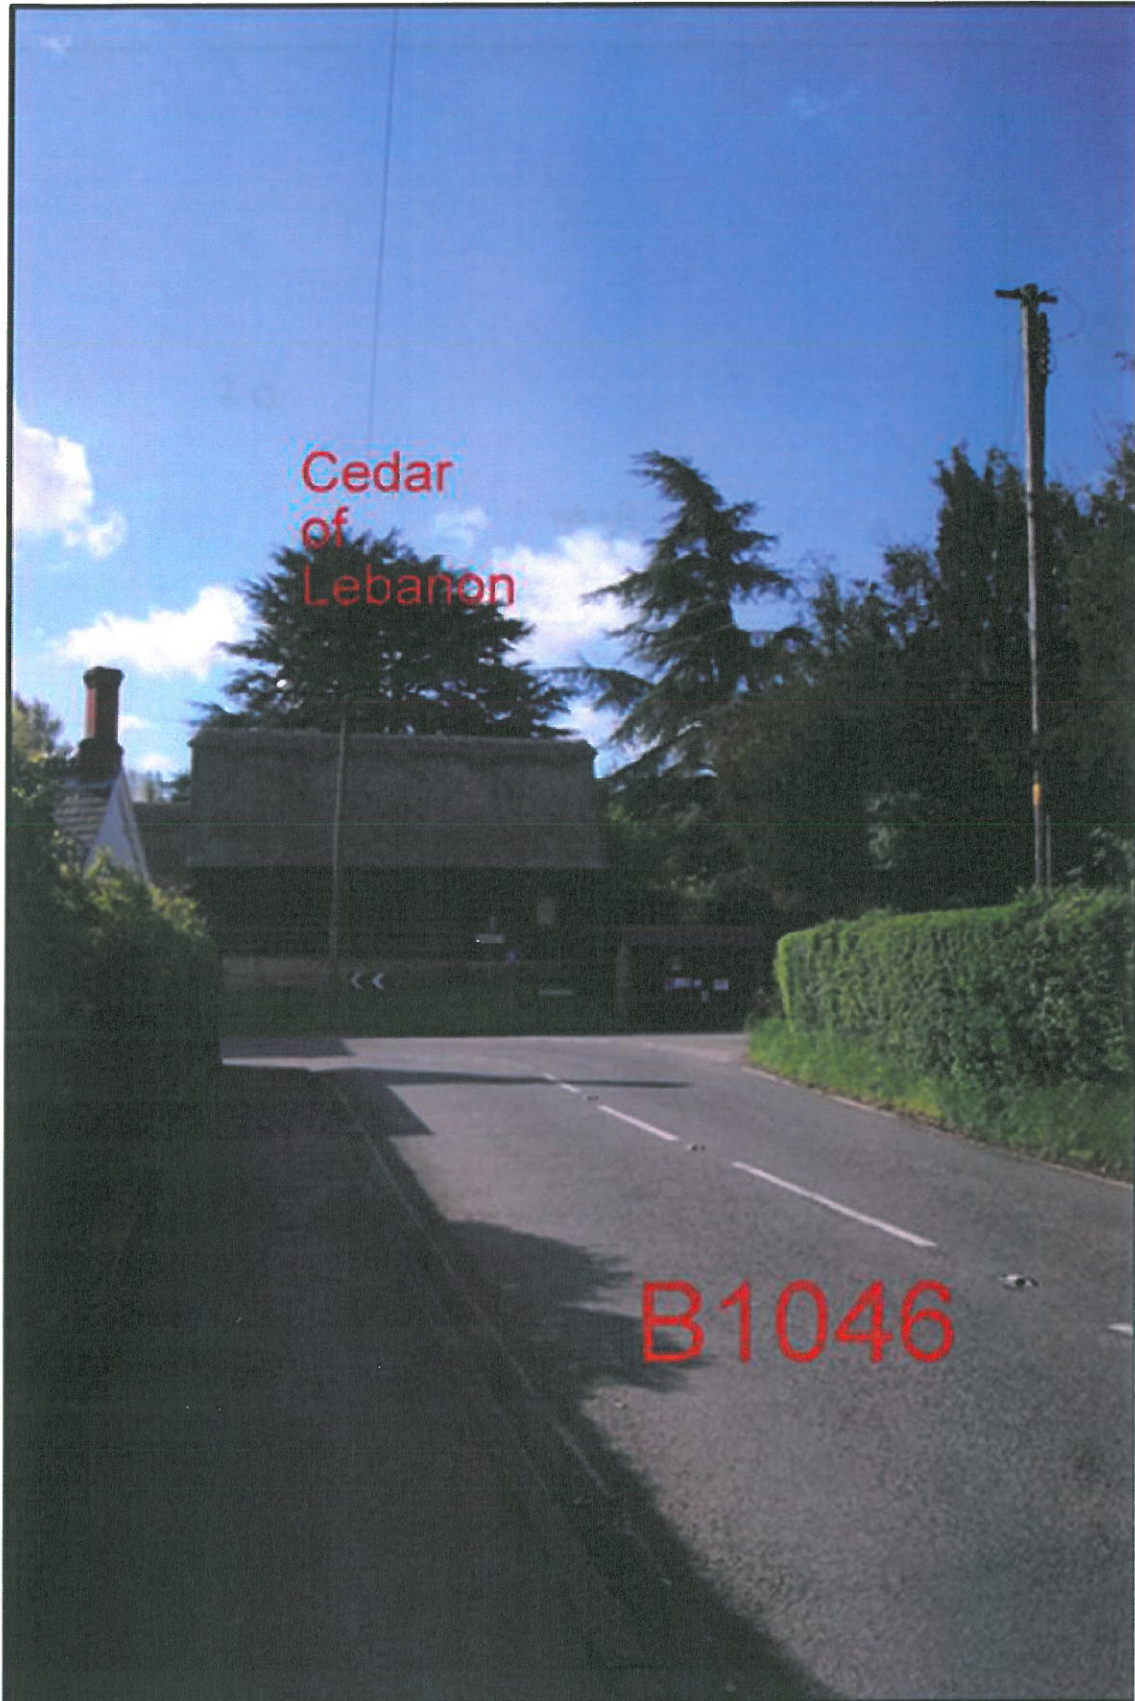
PHOTOGRAPH

The tree in question is a cedar of Lebanon (*Cedrus libani*) 22m in height and 1590mm in trunk diameter at 1.5m above ground level. It is, thus, large and is clearly partly visible from public places. In support of this I noted that the tree is prominently visible from Church Street, and from the B1046 to the N of the site, from which it dominates the view on approach to the village.
