**7 HIGH CLOSE
HEYDON
ROYSTON
SG8 8QA**

*Retrofit Coordination Report
23/11/2023*

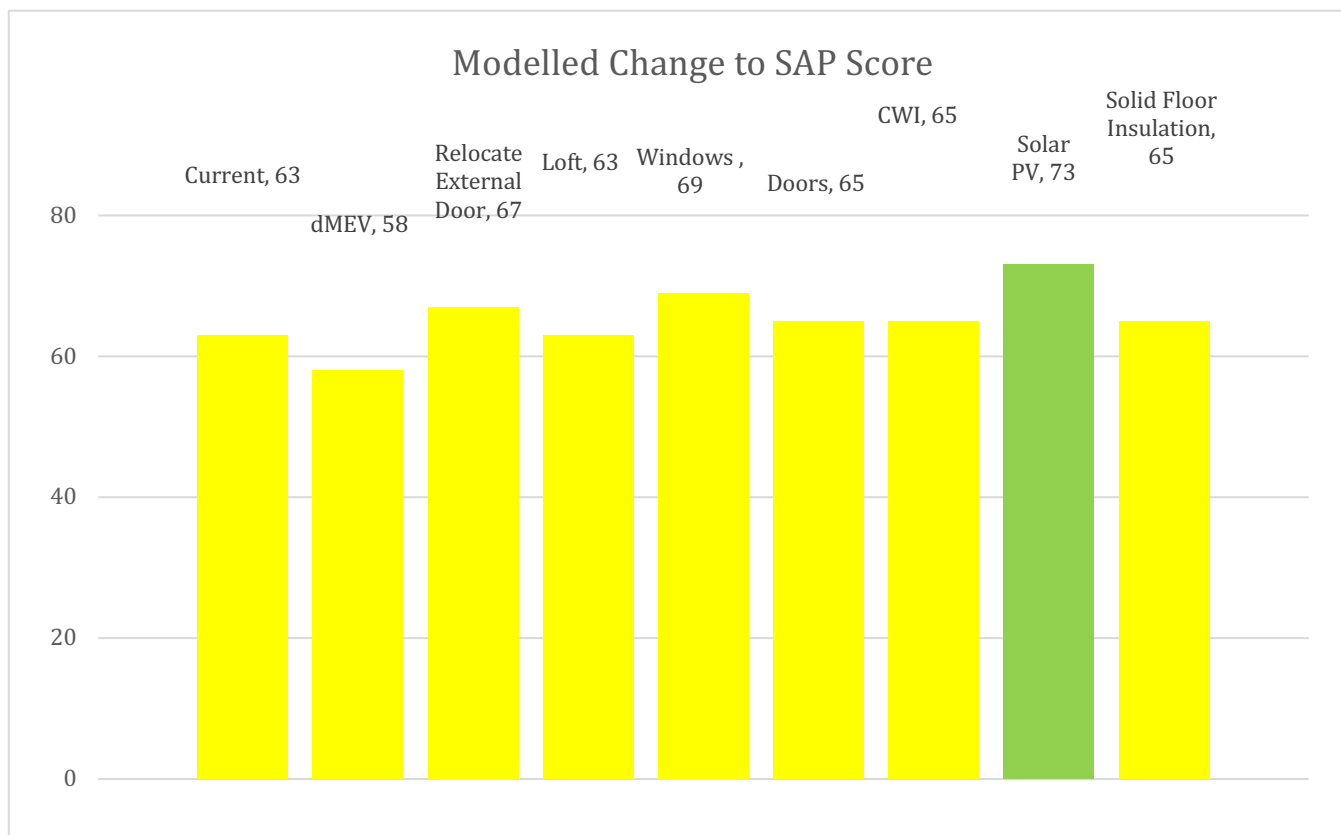
The following graphs display the potential improvements to SHDFs two key metrics when installing recommended measures individually. Beneath, is more detailed information for the individual measures.

Measure	Capital Cost	Annual Fuel Savings	Simple Payback	Lifetime Fuel Savings	Lifetime CO2 Saving	Carbon Cost Effectiveness
Loft Insulation (between/under/over rafters)	£350	£20.00	18 Year(s)	£800.00	3.28 /tCO2	-137.2 /tCO2
Cavity wall insulation	£1,500	£57.00	26 Year(s)	£2,394.00	9.83 /tCO2	-90.95 /tCO2
Solar PV	£5,500	£688.00	8 Year(s)	£17,200.00	24.32 /tCO2	-481.09 /tCO2
Floor insulation (solid ground floor)	£6,000	£74.00	81 Year(s)	£3,108.00	12.68 /tCO2	228.08 /tCO2

New or Replacement Windows	£6,000	£68.00	88 Year(s)	£1,700.00	5.56 /tCO2	834.53 /tCO2
Higher performance external doors with less than or equal to 60% glazing area	£1,000	£19.00	53 Year(s)	£475.00	1.19 /tCO2	600.84 /tCO2

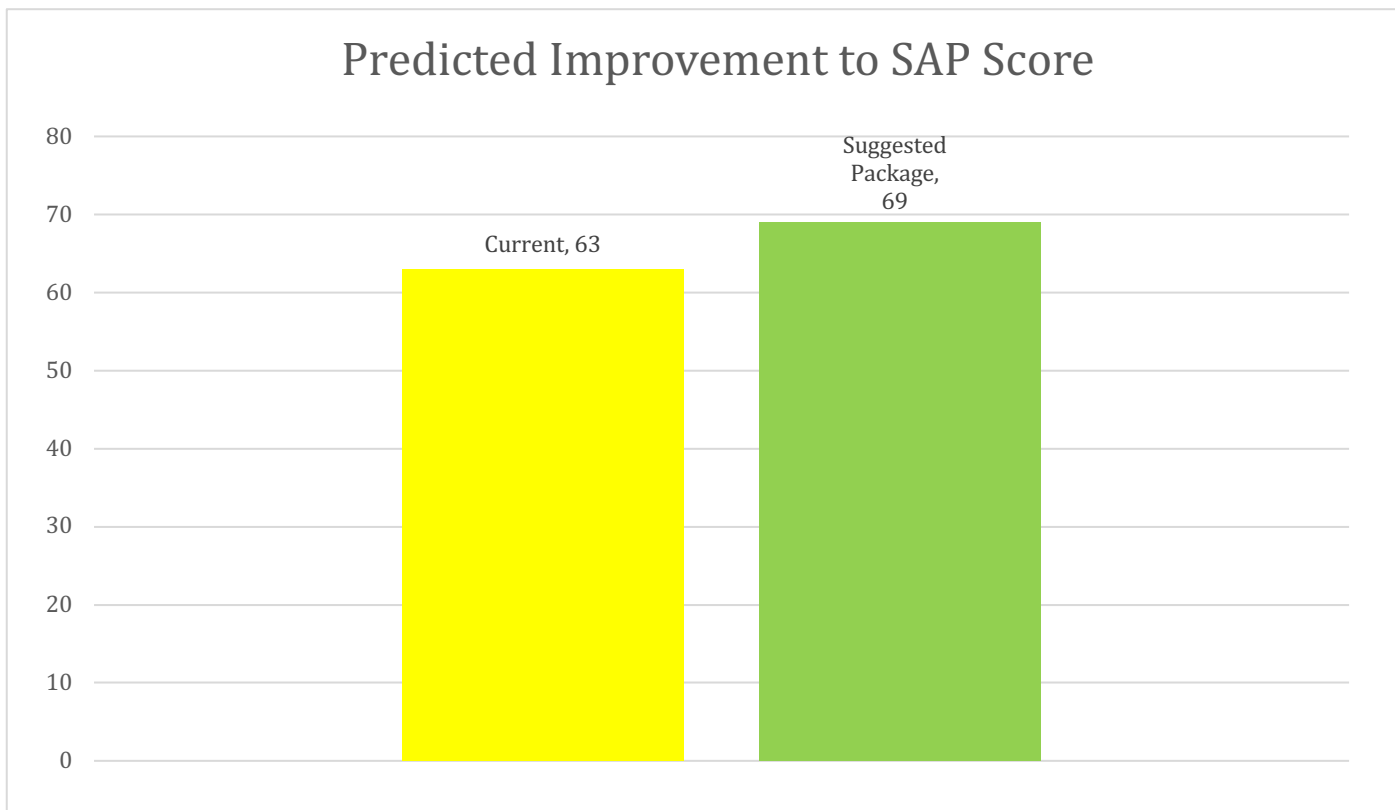
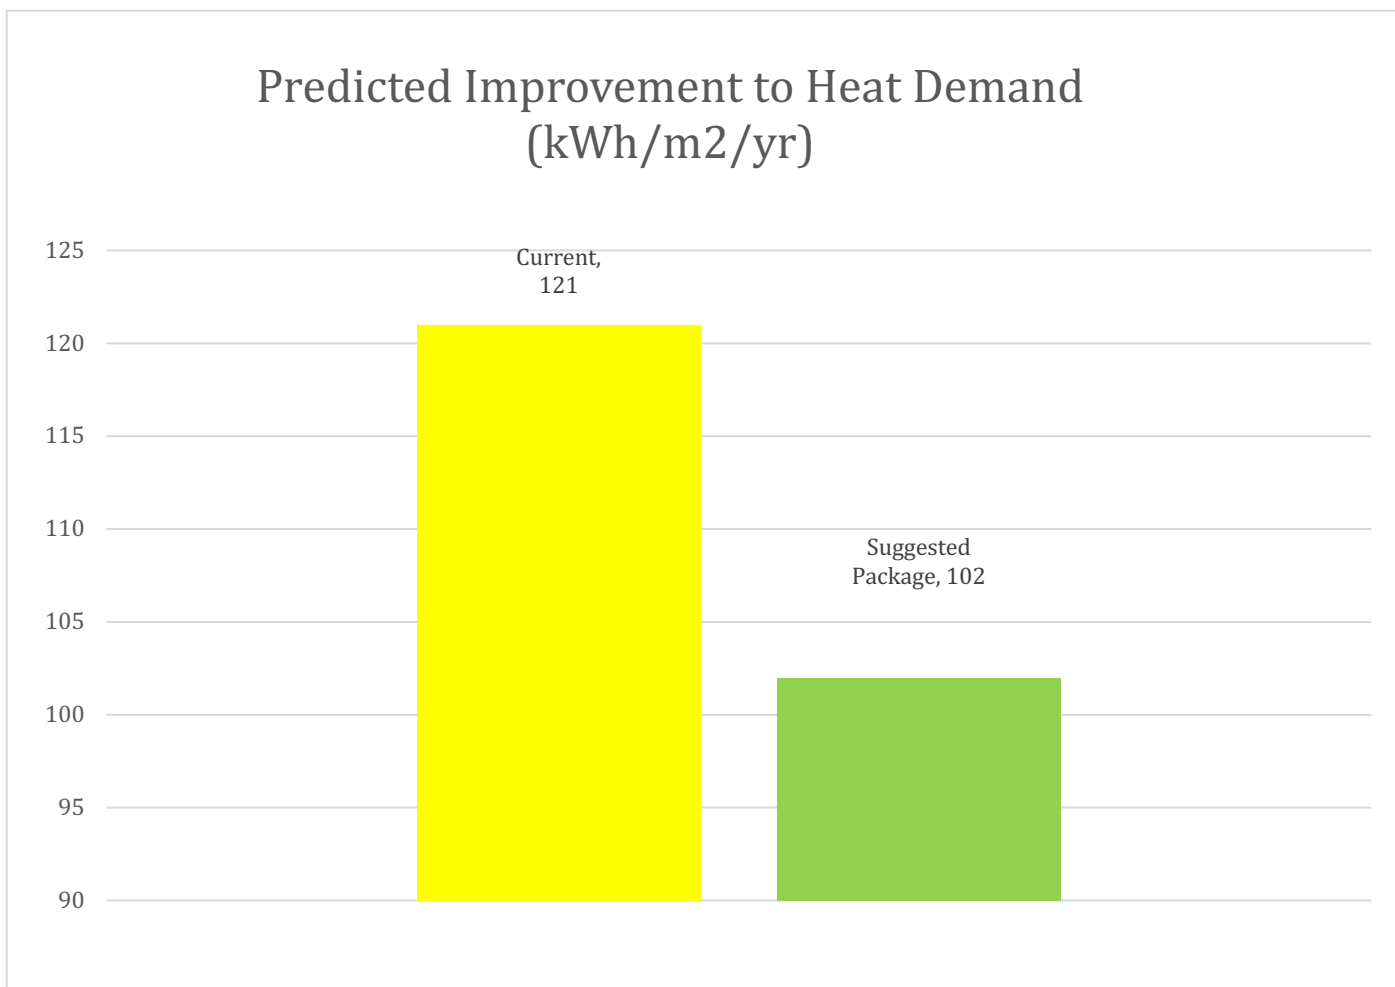
Recommended package of measures to be installed

CWI extract and refill, loft top up, insulated loft hatch, windows, insulated doors (relocate rear door to the kitchen to make the extension outside of the heat loss perimeter) and dMEV.

Measure	Capital Cost	Annual Fuel Savings	Simple Payback	Lifetime Fuel Savings	Lifetime CO2 Saving	Carbon Cost Effectiveness
Package 1 - Loft Insulation (between/under/over rafters), Cavity wall insulation, New or Replacement Windows, Higher performance external doors with less than or equal to 60% glazing area	£8850	£164	54 Year(s)	£5369	19.86 /tCO2	1207.22 /tCO2
