CHAPTER 11

SPECIFIC HISTORIC DETAILS OF LISTED BUILDINGS

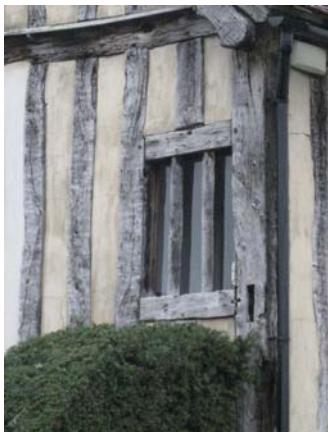
*Example of a Mediaeval
Diamond mullioned timber*

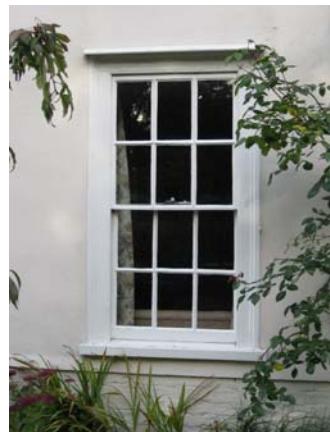
Example of a casement

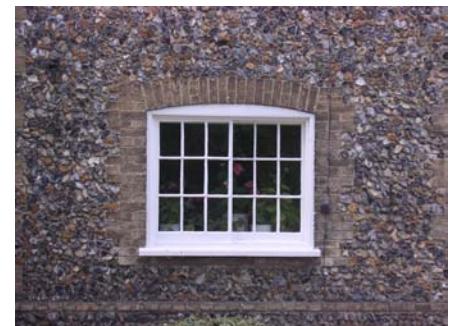
Example of a sliding sash

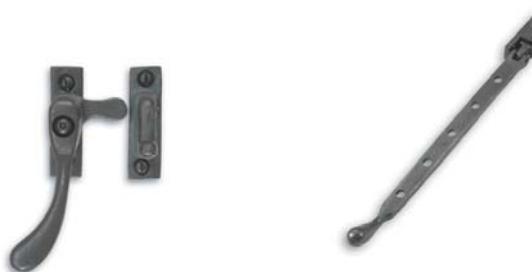
Typical window opening mechanisms for traditional casements

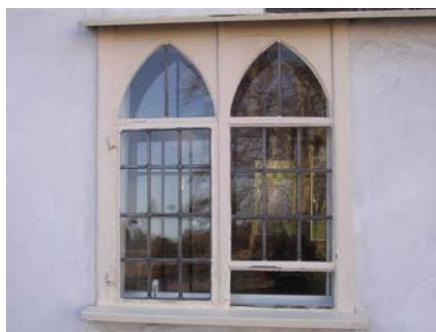
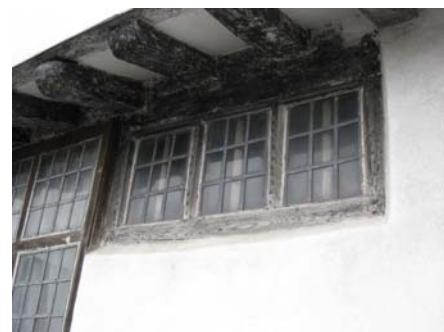
Example of leaded light windows (one on left also has secondary glazing)

- 11.16 Leaded lights are some of the earliest forms of glazed windows. They did not become common in large houses until the late 16th century and in small houses until the late 17th century. Early glass was cut into diamond panes (quarries) from blown discs of glass and held in place with thin strips of lead (cames). These early lattices did not open and were wired to the bars of timber mullioned windows or to iron bars (saddle bars). In the 17th century rectangular quarries became common and opening casements were introduced by inserting glazing into wrought iron and later, cast iron frames. The use of leaded lights continued into the late 18th century, when they were used mainly for cottages, and gained popularity in the 19th with the revival of the Gothic and Queen Anne styles and in the early 20th century with the vernacular revival of the Arts and Crafts period.

- 11.17 Where leaded lights exist they should be retained and repaired by a specialist contractor. Original glass should be salvaged and re-used and any new glass should match the existing as closely as possible.

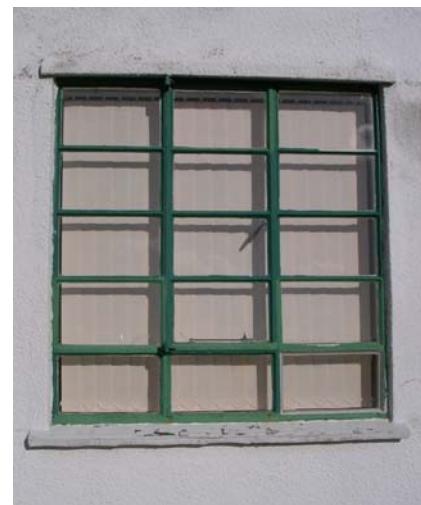
Example of a traditional Crittal window

- 11.19 Steel framed windows were common in the early-mid twentieth century, the best known of which was Crittal. These windows were typical of Art Deco buildings, but can also be seen in numerous cottages and houses. Crittal windows and doors are still in production today and the company can carry out repair work and improvements or replacements as required.

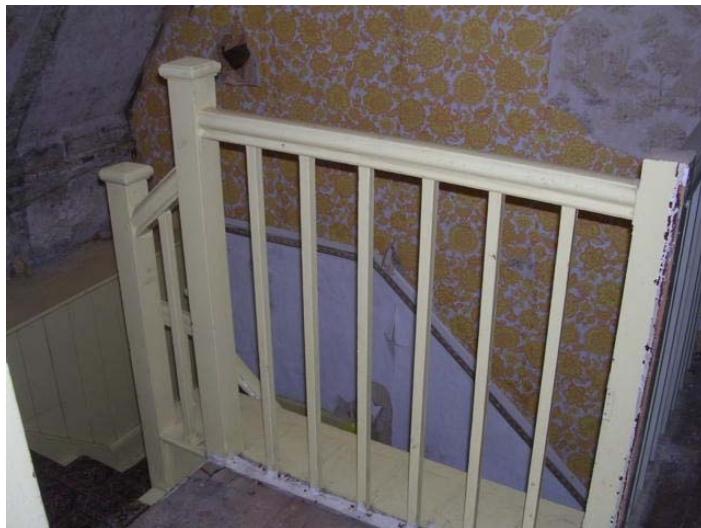
*Example of a simple
and modest stair design*

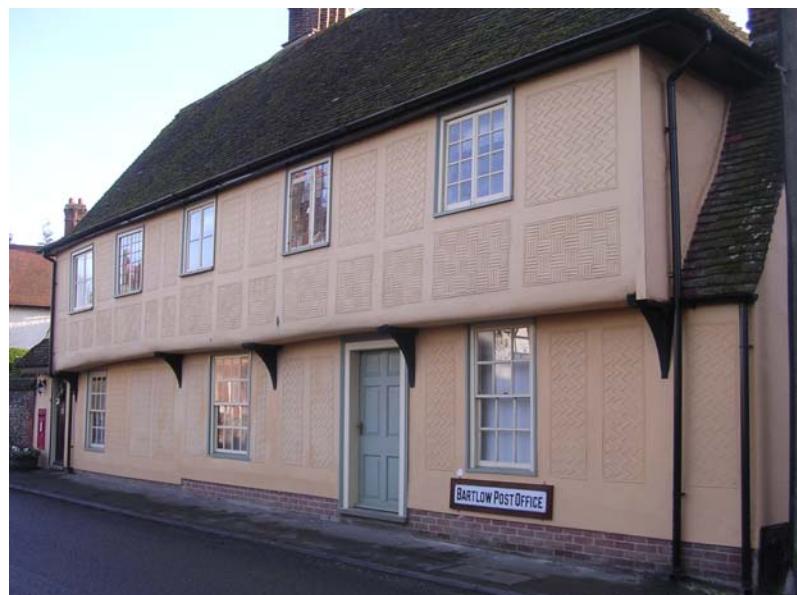
*Example of
pargetting (recently
redone to match
historic)*

- 11.37 The technique of pargetting, or decorative plasterwork, was popular and fashionable in the second half of the 17th century through to the middle of the 18th century. However, there are very few examples of pargetting that remain in South Cambridgeshire. Heavily pargetted buildings can be susceptible to weathering and over time continued limewashing can reduce the crispness of the detailing. Repair and design of pargetting is specialized and should only be carried out by a qualified and experienced plasterer. Listed Building Consent will be required for works other than minor repairs. The only suitable material for this detail is lime.

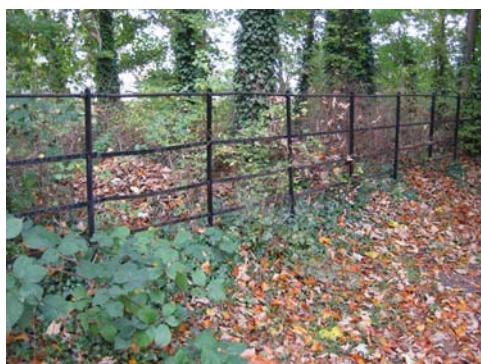
Example of park or estate railings

- 11.51 Iron railings date mainly from the 19th century and are generally associated with buildings of that period, particularly in the larger villages that are more urban in character. Railings were usually inserted into holes cut directly into a stone coping that surmounted a low brick wall and backstays and brick piers were added for support. Flank walls, sometimes curved, and usually completed the enclosure of the front boundary. Few historic examples survive as most were cut down in the Second World War but where there is physical or photographic evidence the reinstatement of railings will be supported.

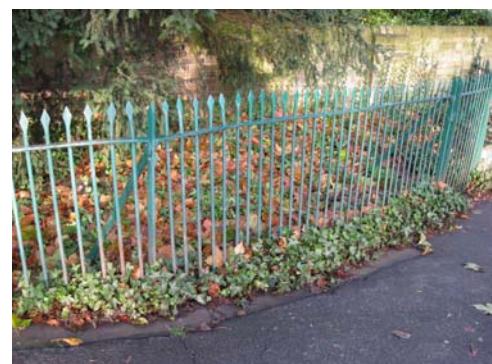
Example of basic railings

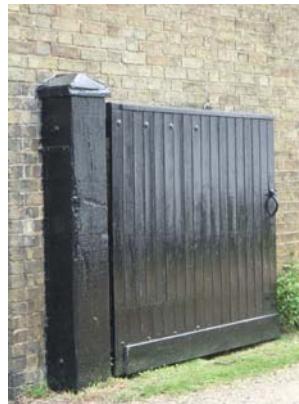
Original historic gate (left)

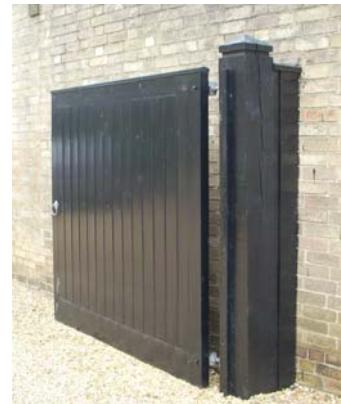
New gate (right)
